FIRE RISK ASSESSMENT

Beeston Hall School - Swindells, Pre Prep, Teaching Block, Art, DT and Out Blds

Beeston Hall School -
Main Block & Music
Block, West Runton,
Cromer, Norfolk, NR27
9NQ

ASSESSMENT REF. RB-IENKYD VERSION 2

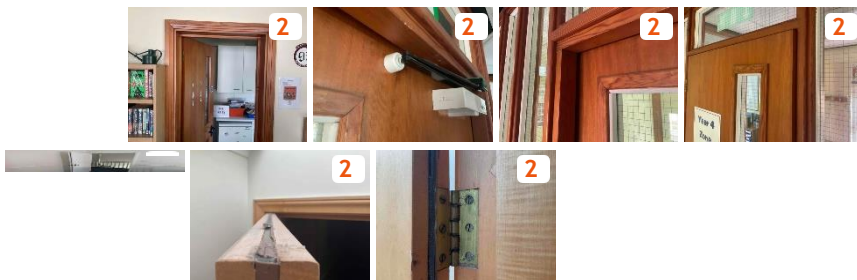
WHY During the assessment, it was noted that throughout the outer buildings, a number of issues were found with the fire doors, such as;

- Various fire doors have excessive gaps between the door leaf or between the leading edge of the door and the door frame.
- Damaged smoke seals and missing intumescent strips were observed,
- Self-closing devices missing from doors leading onto the escape route and from high-risk rooms.
- Fire door signage

LOCATION Throughout the outer buildings

- Due to the number of deficiencies found, it is recommended that a complete fire door survey is undertaken and appropriate remedial works carried out to ensure they function as intended. This should include their fire resistance and smoke control suitability and if replacement door sets are required.
